# **Report for 2005NE100B: Beaver in Agricultural Watersheds: Potential for Mitigating Degraded Midwestern Streams**

## **Beaver in Agricultural Watersheds: Potential for Mitigating Degraded Midwestern Streams**

**Principal Investigators:** Dean E. Eisenhauer, C. William Zanner, Scott E. Hygnstrom and Micheal G. Dosskey

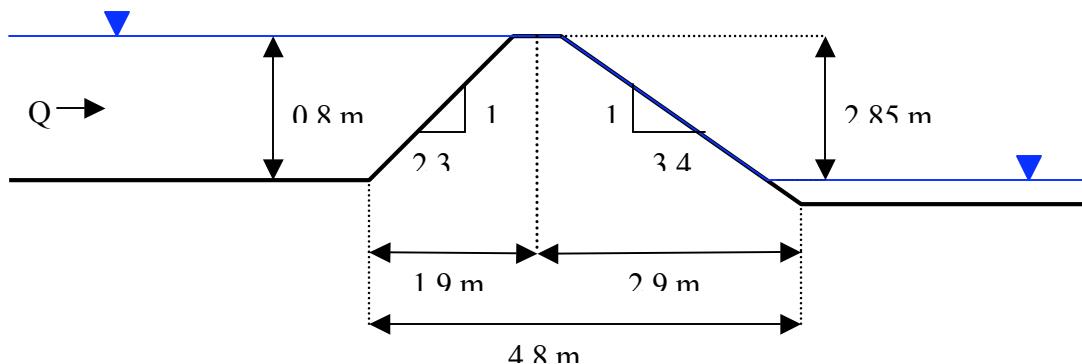
A replica beaver dam was constructed in the laboratory based on the survey of a beaver dam on Little Muddy Creek (Figure 1). Actual dimensions of the beaver dam were replicated in the laboratory, with the exception of the actual dam width. The laboratory channel was 0.91 m wide, while the actual beaver dam surveyed was 3.7 m wide. The replica beaver dam consisted of a pressure-treated plywood structure installed into the laboratory channel. The smooth plywood simulates the smooth mud surfaces on the upstream slope of beaver dams that we observed. Sticks from actual beaver dams in the field were collected and attached to the plywood replica dam to mimic roughness observed in the field. They were fastened to the dam with small wire.

**Figure 1.** Representation of the side profile of a beaver dam on Little Muddy Creek. Drawing is not to scale.

Field observations and photos were used to mimic the structure of the sticks on the dam. Larger diameter sticks were first attached to the bottom of the downstream face of the dam with gradually smaller diameter sticks being attached while working up the downstream dam face. The pattern of stick attachment was similar to shingling a roof, with the sticks on the top of the dam covering the sticks further down the dam on the

downstream face. No sticks were attached to the upstream face of the dam, replicating the smooth mud surface of the beaver dams observed in our watershed.

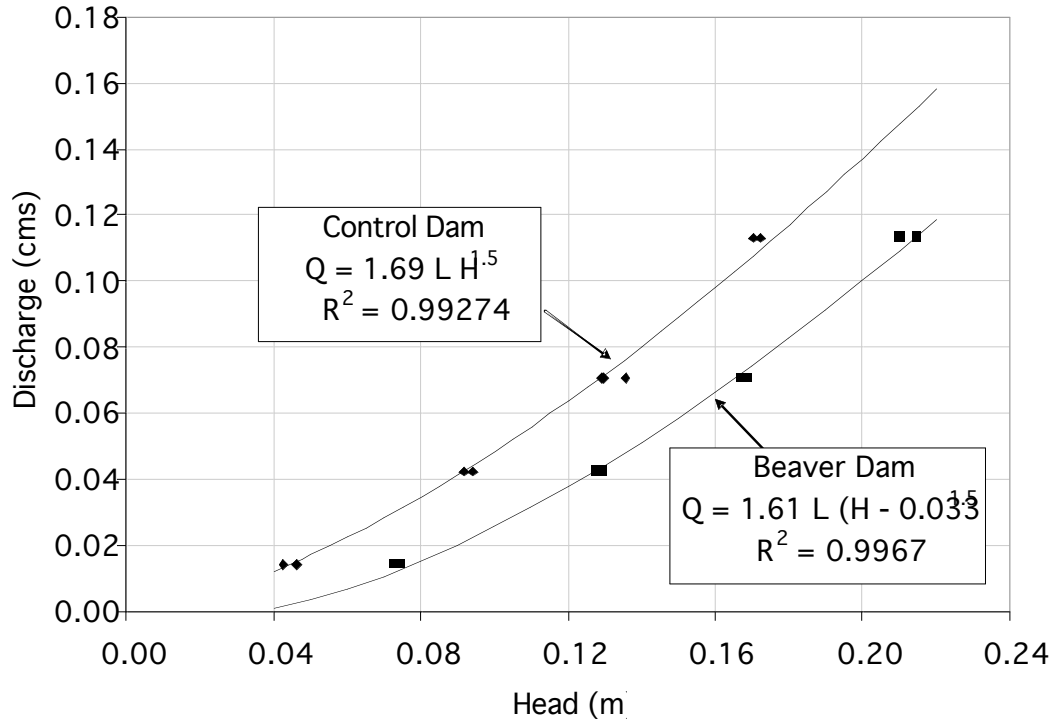
When compared to the smooth dam, the replica beaver dam showed an increase in water surface elevation for each of the four flow rates (Figure 2). This increased water surface elevation was approximately 30 cm for the lowest flow rate and 60 cm for the

highest flow rate. The rating curve fitted for the control dam was:  $Q = CLH^{3/2}$ , where  $C = 1.69 \text{ m}^{1/2}/\text{s}$ . The rating curve for the replica beaver dam was  $Q = CL(H-H_0)^{3/2}$ , where  $C = 1.61 \text{ m}^{1/2}/\text{s}$  and  $H_0 = 0.033 \text{ m}$ .

**Figure 2.** Rating curves for control dam and simulated beaver dam.

The laboratory tests showed an expected result, that the roughness of the sticks led to increased water height upstream of the dam compared to a smooth dam of equal base dimensions. While the replica beaver dam was constructed to be as realistic as possible, we were restricted from using mud on the dam, which may result in a

The results of laboratory testing of a beaver dam replica indicate that it was reasonable to model these structures as broad-crested weirs, but it appears that it may be necessary to adjust the crest elevation of the dam with an offset. In the present case this offset was about 3 cm, but the offset likely depends on geometric characteristics of the dam.

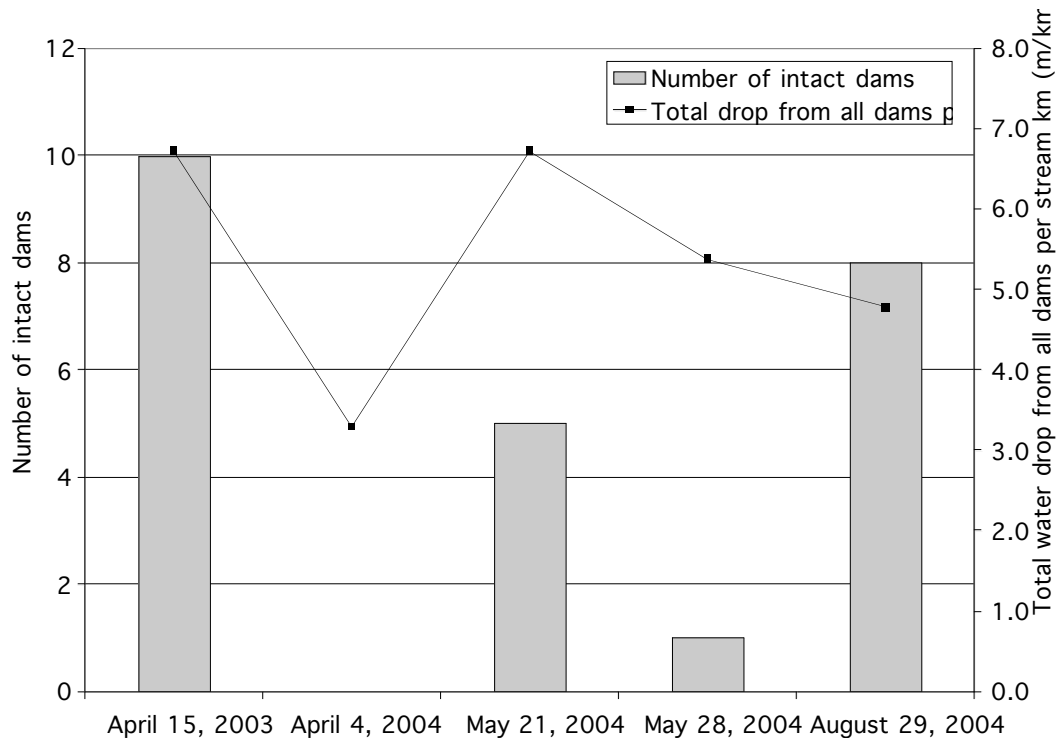
The field surveys of beaver dams showed a wide variation in hydraulic status of individual dams over the period from 2003 to 2005 (Figure 3). Dam integrity was seen to be compromised by storm runoff and general decline due to abandonment of the area by beavers. Dams that were damaged by increased storm runoff were not consistently repaired by beavers and repair may vary seasonally, however data is limited in making an assessment of seasonal beaver activity. The total water level drop per stream kilometer tended to correlate with the number of intact dams with the exception of the August 29, 2004 survey, when the number of intact dams increased while the total drop/km decreased. This data suggests that although the number of dams that were repaired had increased, they had not rebuilt to previous heights. This may be due to beavers abandoning the area or decreased dam building activity during the summer months.

**Figure 3.** Number of intact beaver dams over the survey period and impacts of the beaver dams on water drop.

Hydraulic characteristics of beaver dams in our watershed were observed to vary temporally over both long and short term periods. This is a very significant finding because to accurately model the long-term impact of the dams on the stream morphology the temporal nature of the dams will have to be adequately described. These variations occurred with both dam structure and locations. Dam structure varied over both longer and shorter periods of time. For example, some dams damaged by storm runoff were repaired within a period of weeks while others were never repaired, their structure disintegrating over a longer period of time.
